Docket No. 217 – Development and Management Plan Inspection

Northeast Utilities Service Company Certificate of Environmental Compatibility and Public Need for the construction of a 345-kV electric transmission line and reconstruction of an existing 115-kV electric transmission line between Connecticut Light and Power Company's Plumtree Substation in Bethel, through the towns of Redding, Weston, and Wilton, and to the Norwalk Substation in Norwalk, Connecticut.

Date: August 24, 2005

Location: 345kV XLPE Component

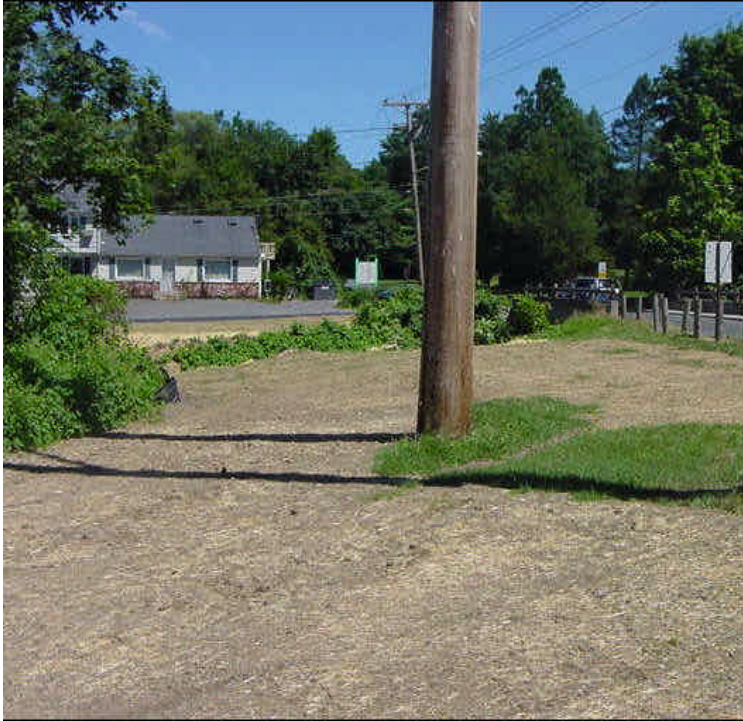
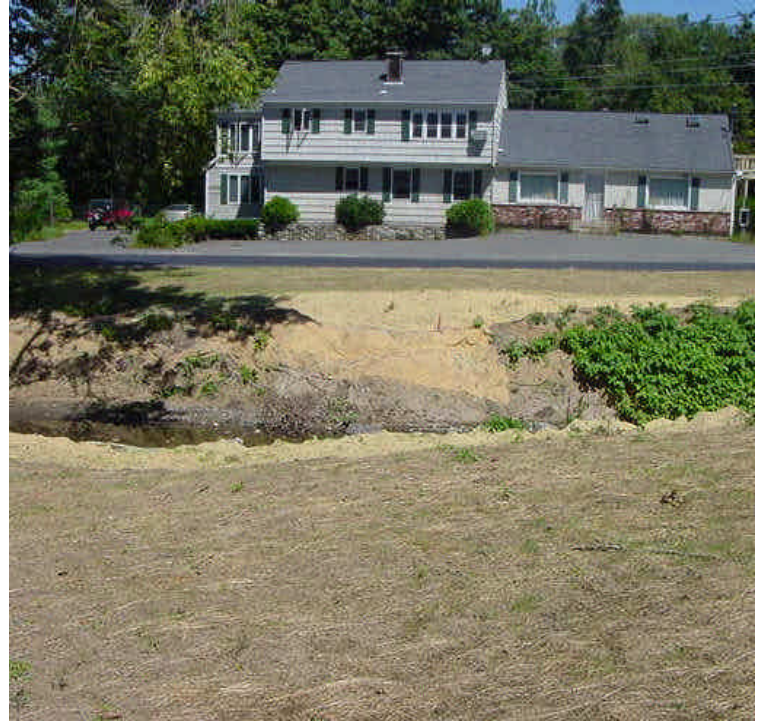
Both photos show the restoration efforts along the stream banks and within the ball park lawn area. Vegetative cover was beginning to establish here and erosion control mats remain in good shape. 8/24/06

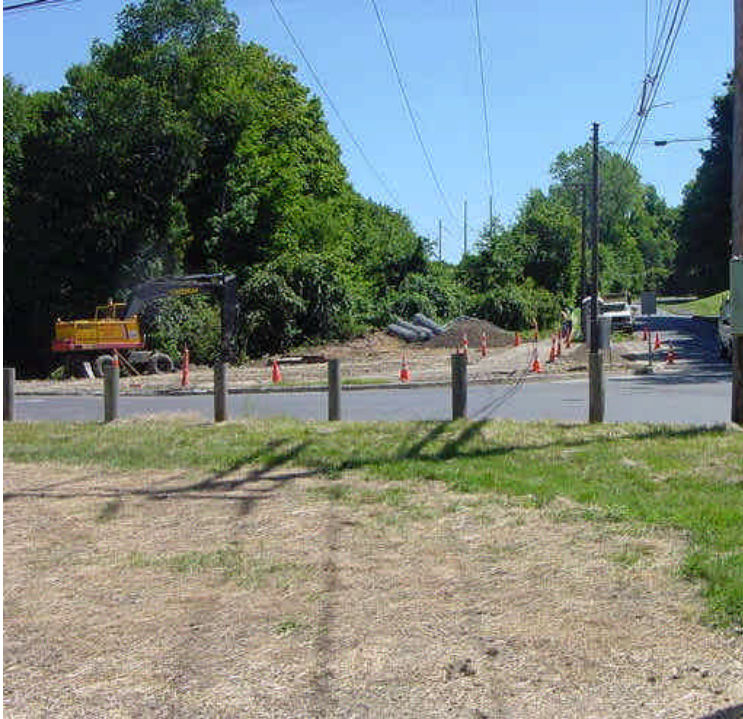
Areas of Inspection	Observation	Recommended Action	Corrective Action
Trench and foundation construction	<p>-The chain link fence was removed from the jacking pad and the area is being graded. A few stockpiles remain 8/24/06</p> <p>-Vaults were being accessed along the route to pull and splice cable in a number of locations. 5/25-8/16/06</p>	<p>-See erosion control section for recommendations. 8/24/06</p> <p>-None at this time. 8/16/06</p>	<p>-N/A</p> <p>- N/A</p>
Erosion and Sediment Controls (includes inspection within 24 hours of a storm event)	<p>- Vault access at 2A&B resulted in the need for vehicle parking in the adjacent, temporarily restored areas. 8/16-8/24/06</p> <p>-The erosion control blankets remained in place along the bank and the top of slopes were starting to show vegetative growth. 8/24/06</p> <p>- The silt fence along the ball park access was in place and the lawn area was starting to show grass growth. 8/24/06</p> <p>- Grading work continues at the jacking pit pad. The corner of silt fence is down 8/16/06</p> <p>- Vault 5 is one of the few remaining areas to restore following access. All other areas with temporary parking will need to be reseeded as well. 8/16-8/24/06</p>	<p>-The area will need to be re-seeded when access is complete. 8/16-8/24/06</p> <p>-Continue to monitor until vegetation has established. 8/16-8/24/06</p> <p>- Continue to monitor until vegetation has established and restore the adjacent trailer parking area in the park. 8/24/06</p> <p>-Repair the fence when feasible but no stockpiles are located immediately adjacent. 8/16/06</p> <p>- Continue to monitor and restore when access finishes up. 8/16-8/24/06</p>	<p>-Needs attention when access is complete.</p> <p>-Vegetative growth was returning</p> <p>-The lawn area was restored.</p> <p>- Needs attention when feasible</p> <p>- N/A until access is done.</p>

Photo on the left shows the demobilization at the jacking pit. Chain link fence was removed and the area was being graded. Photo on the right shows the wetland at the base of slope at Hoyts Hill following recent restoration. Vegetation is returning here. 8/24/06

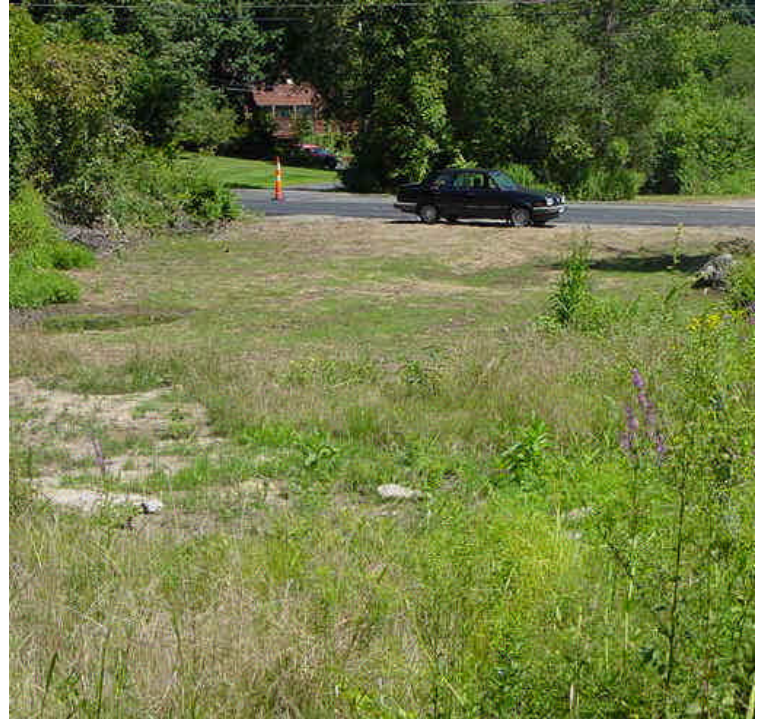
Areas of Inspection	Observation	Recommended Action	Corrective Action
encroachment and mitigation	- Mats were removed from the wetland at the base of slope at Hoyts Hill. The wetland was restored and mulched with straw. One large boulder remains here. 8/16-8/24/06	- Continue to monitor until final stabilization. Vegetative growth was noted. 8/24/06	-Vegetative growth was noted
State species of concern, threatened and endangered species	-The D&M plan and clearance letter states that state-listed species are not located in this work area. -The wood turtle was noted at Plumtree Substation during the 5/25/06 inspection.	- N/A -345kV XLPE crews should also be performing daily walkthroughs before moving equipment if working in this vault. Be vigilant when moving equipment. 4/26-8/24/06	-N/A - Crews were informed
Vegetative clearing limits (including trees to save or danger trees noted)	- Most restored areas had noticeable grass growth. A few vaults required parking in previously restored areas. 8/24/06 - The area near vault 5 remains to be restored 8/24/06 - The jacking pit pad will also need restoration when work is complete. 8/3-8/24/06	- Continue to monitor for final stabilization and restore any recently/ currently accessed areas as necessary. 8/16-8/24/06 - Remaining areas will be restored when access needs are complete. 7/5-8/24/06 - Restore when feasible. 8/24/06	- N/A - N/A until access needs are complete -N/A at this time
